# The history of mortar

THE DEVELOPMENT OVER TIME OF MORTAR AND RENDER

*by Knut Åkesson*

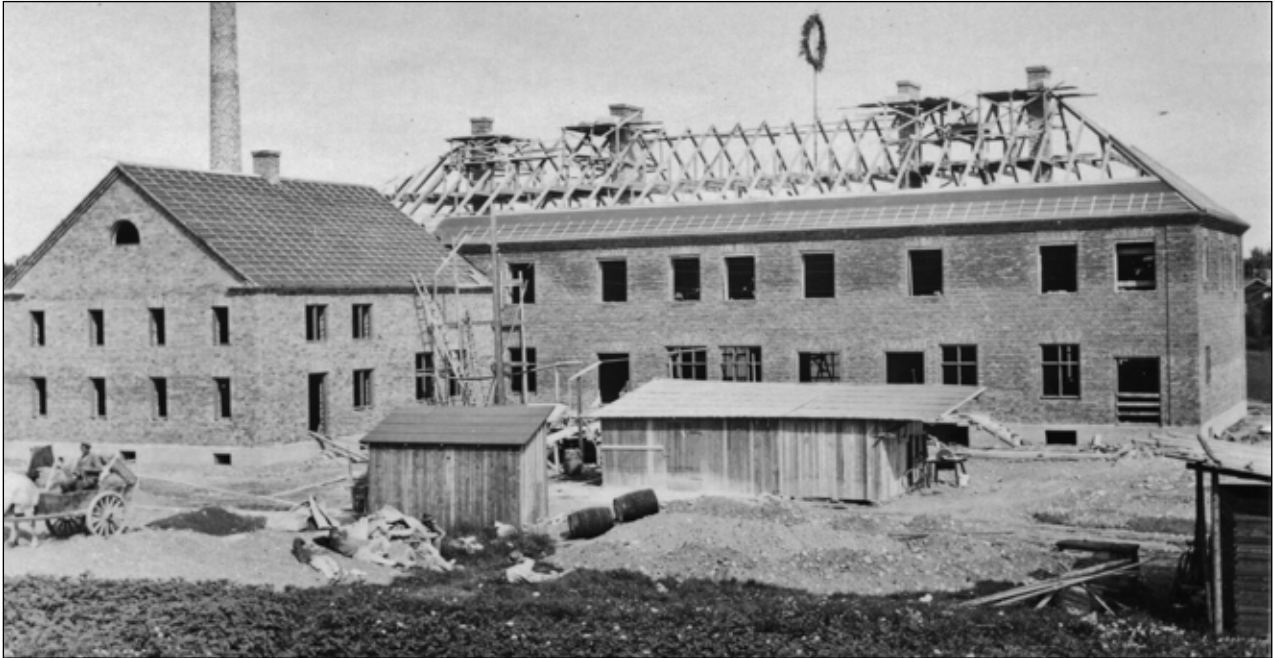
*Krylbo dairy 1926, from the archive of Lars Östlund.*

The photograph shows how a bricklayer's workplace looked in 1926. The machines and safety measures we now take for granted were totally absent. All work was performed by hand. The brickwork is constructed with block-jointed, full-sized red brick from Bältarbo, with beaded jointing and beautiful vaulting over the apertures.

The brick format is approximately 295 x 140 x 70 mm. The chimneys have been completed and roofing is under way prior to the completion during the autumn of the facade joinery and interior rendering. A potato patch is in flower in the foreground. On the left can be seen a horse and cart with the carter in his seat after delivering coal. Some workmen are resting on the grass in front of the smaller shed (the limeshed). Several of them are wearing typical bricklayers' clothing.

To the right of the limeshed, a couple of wooden quicklime barrels which have been emptied of their contents of burnt limestone, CaO, are lying in the gravel.

The lime shed was where the quicklime was slaked with water and whisked together with aggregate to make mortar and render which were strengthened by the addition of cement and gravel to make concrete for the foundations and beams. The ground between the sheds and the bottom of the larger shed are white from lime and cement spills.

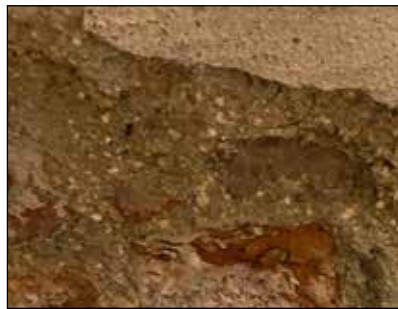
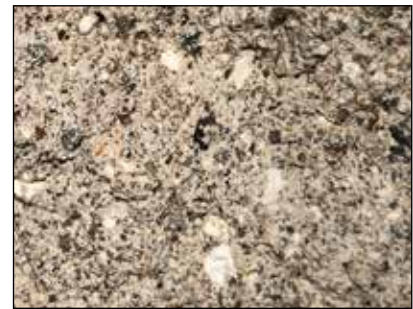
*Lime-rich mortar and render without contraction cracks showing roasted soft lumps of limestone. That on the left is from the late middle ages and on the right from the 18th century. Both with equal parts by weight of lime and whichever aggregate was available.*

Analysis of older intact mortars typically reveals that the proportions by weight of lime and aggregate are nearly equal. One part lime with a low content of binder was whisked with an equal part of aggregate.

This did not lead to the problems associated with shrinkage that always occur when the proportion of binder exceeds 13% by weight.

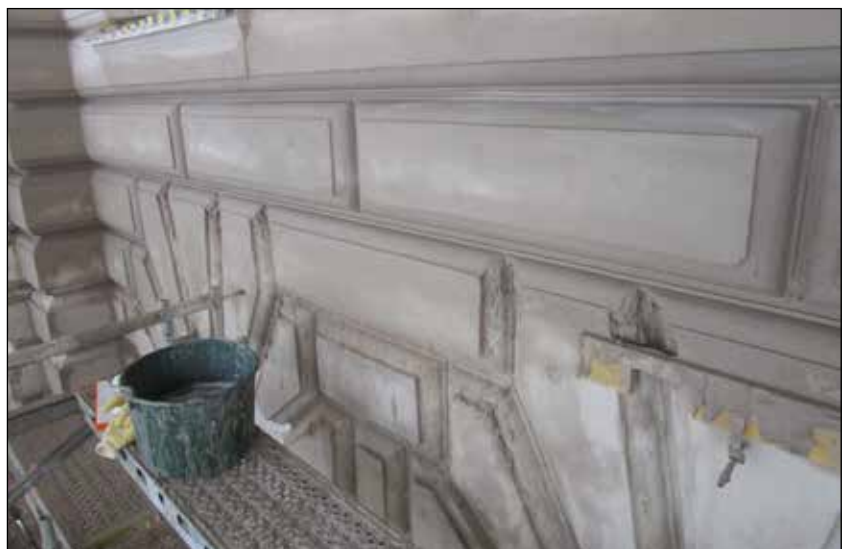
*Template moulding in lime render.  
Photo: Simon Patetsos, TP Mur & Puts AB*

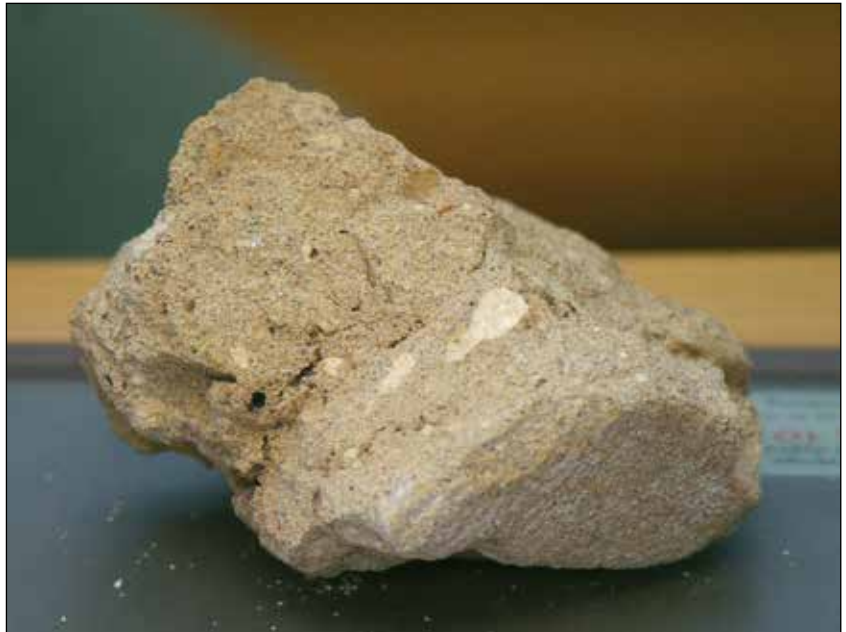
*400 year mortar with small lumps of limestone and fragments of charcoal.*

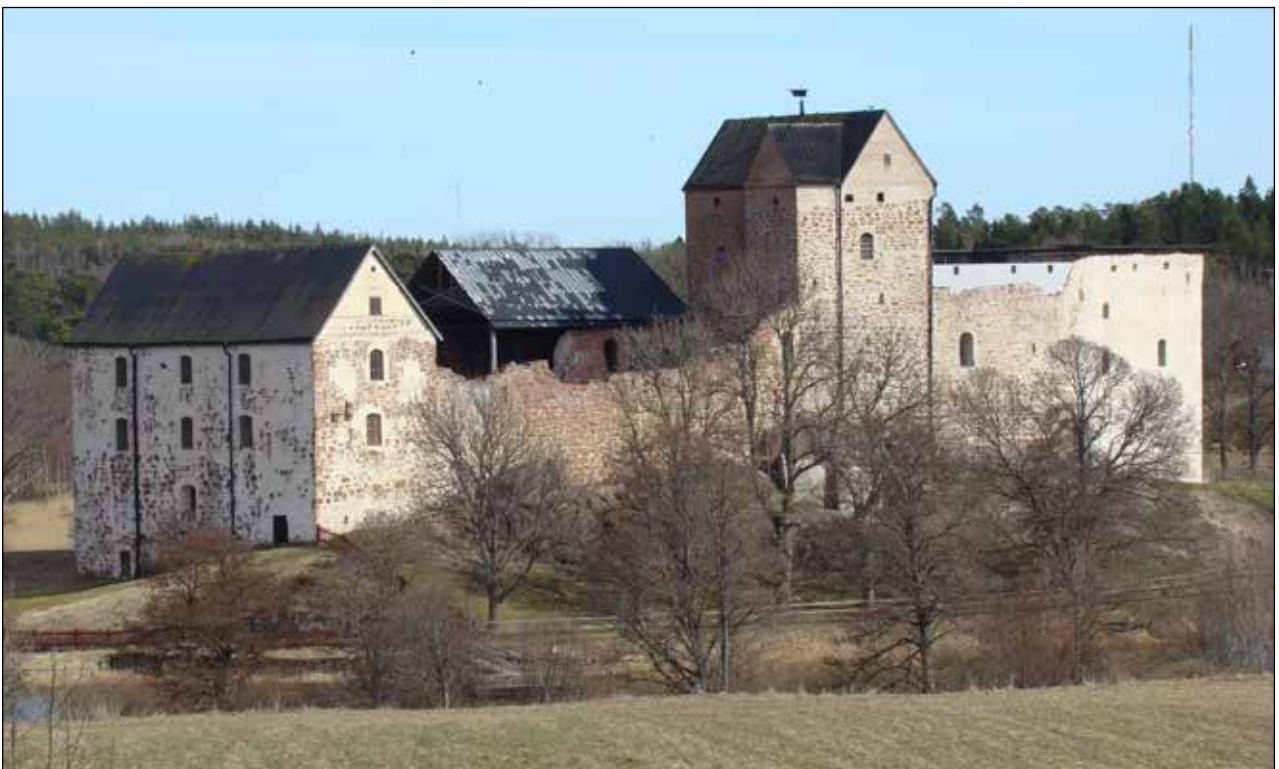
*Elastic joints permit the use within certain limits of larger and smaller building stones without these affecting the neighbouring stones.*

The lime-rich mortar we today call 1:1 is so elastic that it absorbs movements even from the temperature-driven volume changes of large stone blocks in such a way that the forces do not increase and spread sideways.

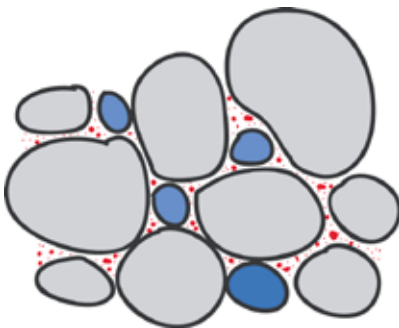
*This sand-rich mortar is called 1:3 and is bound with lime and/or cement. The plasticity and porosity of the mortar are achieved through the addition of various chemicals.*

Over time and with the increase in construction, production developed into an industry where nearly all the limestone that is burned is converted into binder,  $\text{Ca}(\text{OH})_2$ , which can be used in mortar up to a maximum of 13 per cent by weight.

**Throughout almost all the twentieth century, 1:3 mortar bound with lime and cement was used even for repairs and maintenance of historic buildings. Numerous problems have been observed with these mortars.**

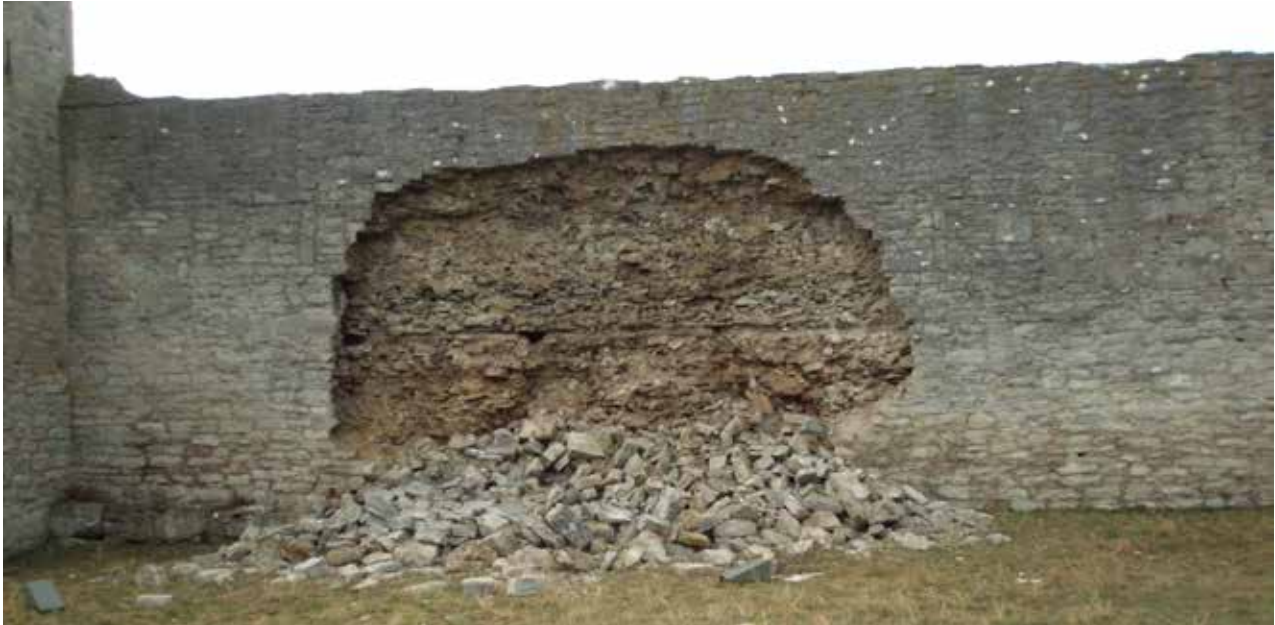
The wall in the photograph below has no protective roof and collapsed at the beginning of the 21st century after having been repointed during the 1950s - 1960s with a lean lime/cement mortar.

The mortar prevented the damp which penetrated through the unprotected crown of the wall from leaving the inner part of the wall. Over time, sideways forces appear and increase in the outer part of the wall to such an extent that bulging portions of the wall are pushed away.

*An example of a wall which was repointed with a sand-rich, non-elastic mortar.*

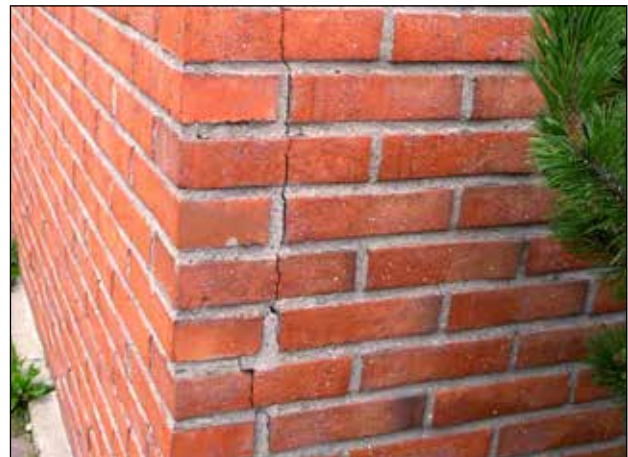
***"When aggregate grains lie glued together in horizontal joints they function together volume-wise like concrete."***

*An example of a brick cavity wall expanding over the corners as a result of the horizontal joints forming long pressure bars.*

The lean mortars lack elasticity, thus requiring the construction of dilation joints. This is necessary even in new brick walls where the horizontal joints form a pressure bar forcing the corners away from the wall.

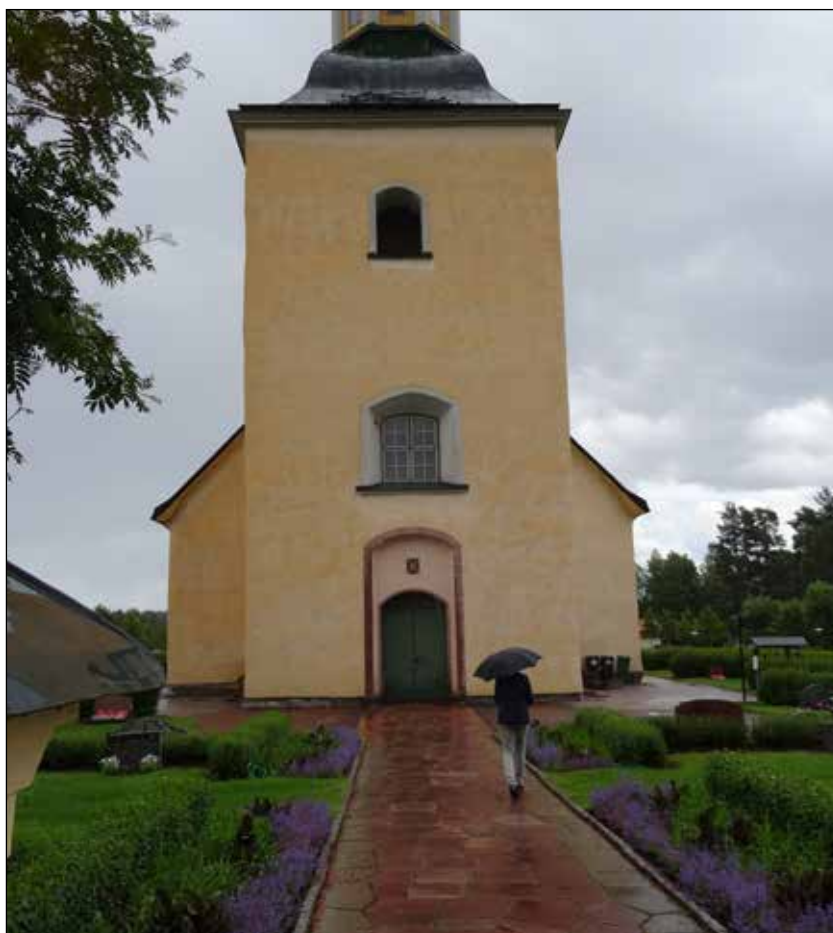
*Våmhus church 25 years after its renovation. 12-7-2020*

In the case of Våmhus church, we removed all the render from the tower in 1996, ground it down and restored it to the correct elasticity with limestone filler and lime binder and re-rendered the tower with a satisfactory result. For further information, consult our brochures on lime mortar.
