The history of mortar

THE DEVELOPMENT OVER TIME OF MORTAR AND RENDER

by Knut Åkesson

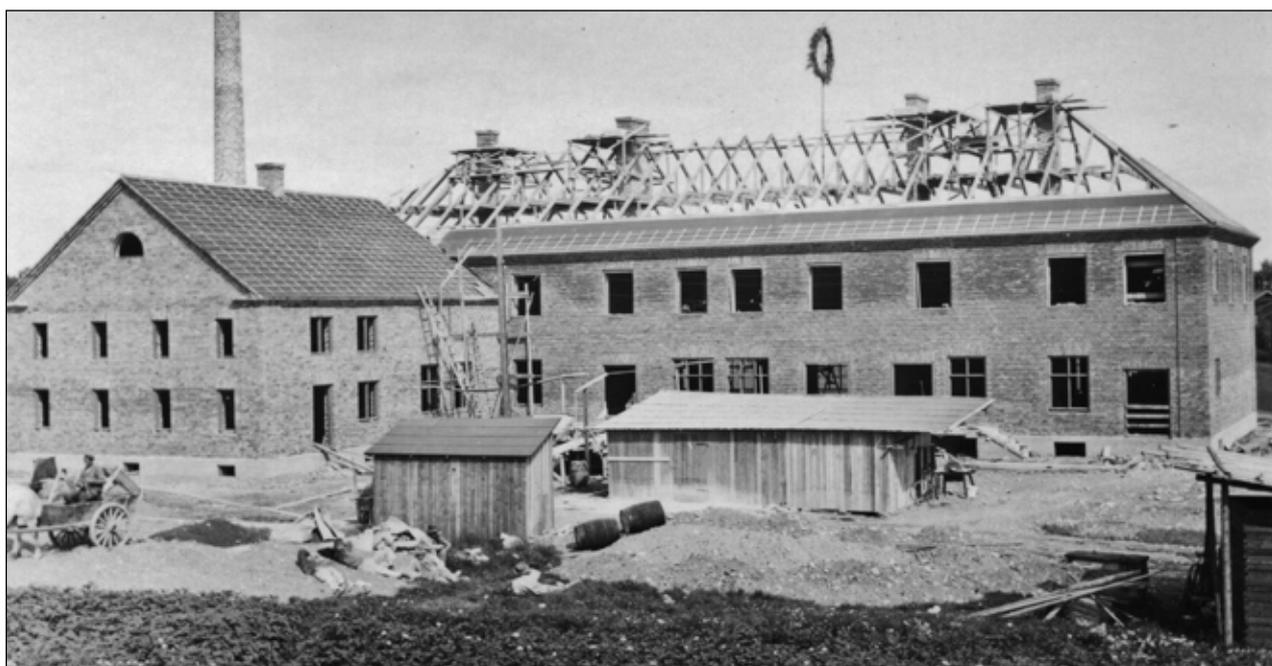
Krylbo dairy 1926, from the archive of Lars Östlund.

The photograph shows how a bricklayer's workplace looked in 1926. The machines and safety measures we now take for granted were totally absent. All work was performed by hand. The brickwork is constructed with block-jointed, full-sized red brick from Bältarbo, with beaded jointing and beautiful vaulting over the apertures.

The brick format is approximately 295 x 140 x 70 mm. The chimneys have been completed and roofing is under way prior to the completion during the autumn of the facade joinery and interior rendering.

A potato patch is in flower in the foreground. On the left can be seen a horse and cart with the carter in his seat after delivering coal. Some workmen are resting on the grass in front of the smaller shed (the limeshed). Several of them are wearing typical bricklayers' clothing.

To the right of the limeshed, a couple of wooden quicklime barrels which have been emptied of their contents of burnt limestone, CaO, are lying in the gravel. The lime shed was where the quicklime was slaked with water and whisked together with aggregate to make mortar and render.

The mortar and render were strengthened by the addition of cement and gravel to make concrete for the foundations and beams.

The ground between the sheds and the bottom of the larger shed are white from lime and cement spills.

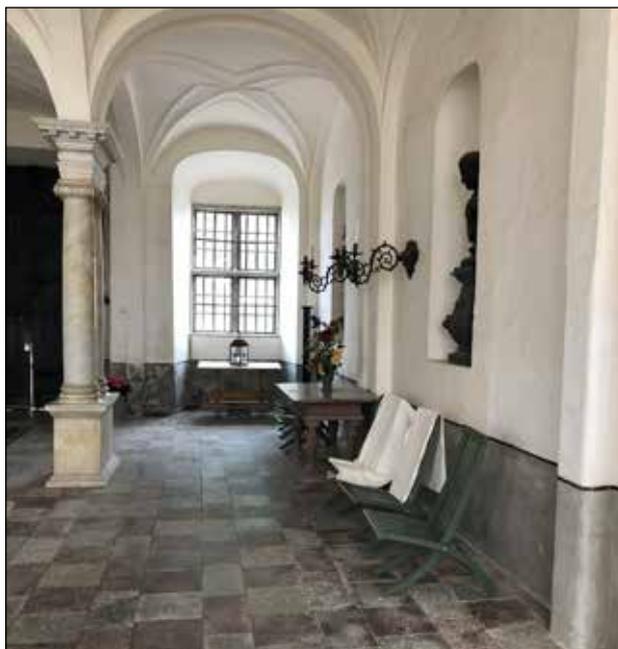
Traditional masonry.

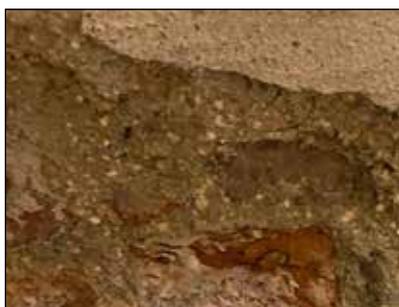
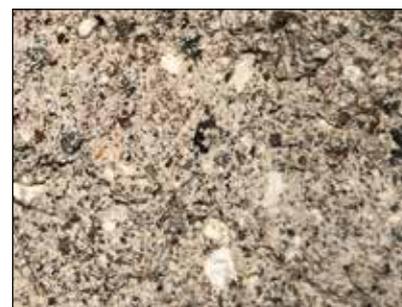
Lime-rich mortar and render without contraction cracks showing roasted soft lumps of limestone. That on the left is from the late middle ages and on the right from the 18th century. Both with equal parts by weight of lime and whichever aggregate was available.

Analysis of older intact mortars typically reveals that the proportions by weight of lime and aggregate are nearly equal. One part lime with a low content of binder was whisked with an equal part of aggregate.

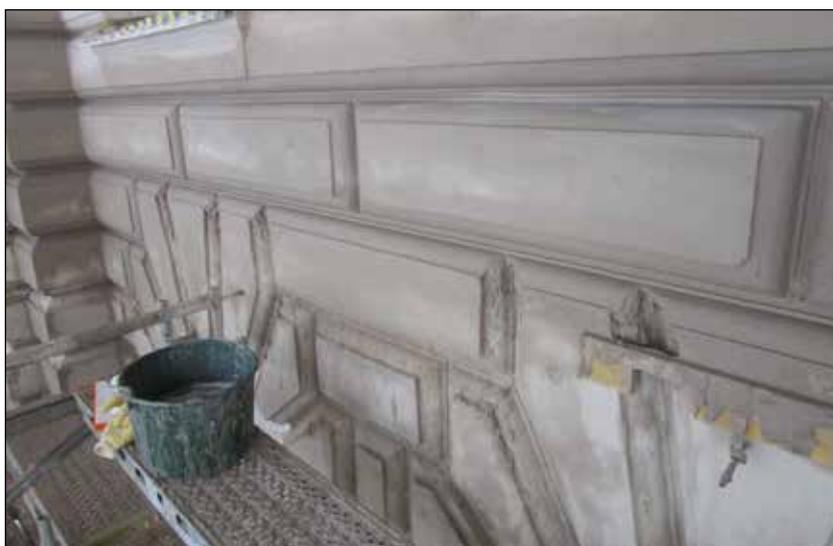
*Template moulding in lime render.
Photo: Simon Patetsos, TP Mur & Puts AB*

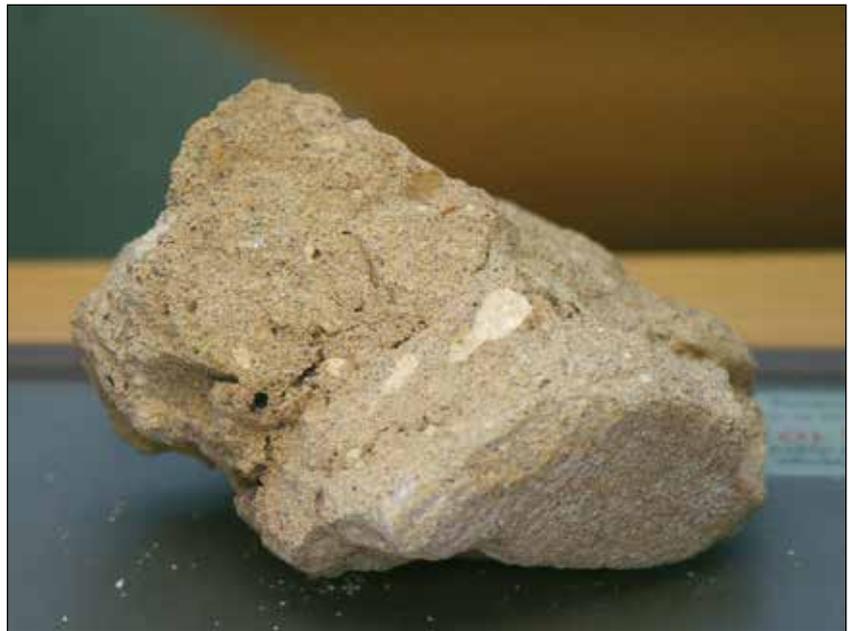
400 year mortar with small lumps of limestone and fragments of charcoal.

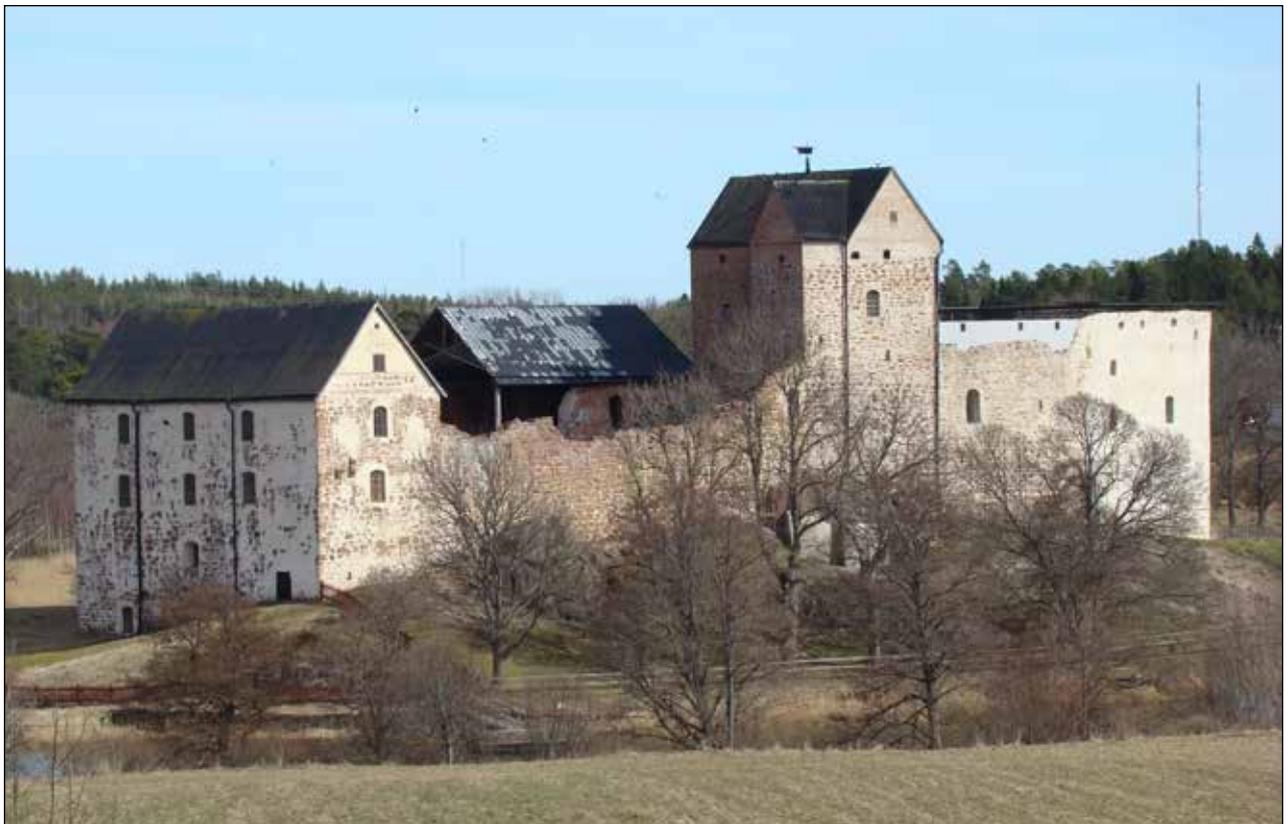
Elastic joints permit the use within certain limits of larger and smaller building stones without these affecting the neighbouring stones.

The lime-rich mortar we today call 1:1 is so elastic that it absorbs movements even from the temperature-driven volume changes of large stone blocks in such a way that the forces do not increase and spread sideways.

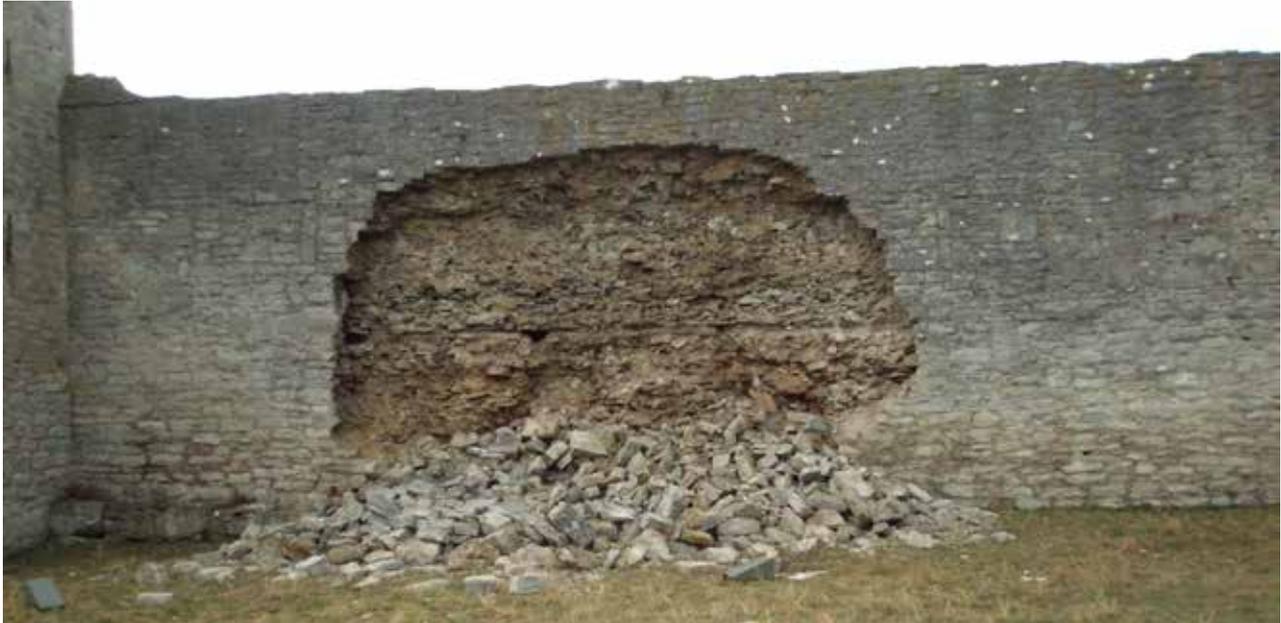
The wall in the photograph below has no protective roof and collapsed at the beginning of the 21st century after having been repointed during the 1950s - 1960s with a lean lime/cement mortar.

The mortar prevented the damp which penetrated through the unprotected crown of the wall from leaving the inner part of the wall. Over time, sideways forces appear and increase in the outer part of the wall to such an extent that bulging portions of the wall are pushed away.

An example of a wall which was repointed with a sand-rich, non-elastic mortar.
